UNITED STATES AIR FORCE
AIRCRAFT ACCIDENT INVESTIGATION
BOARD REPORT

C-130J, T/N 08-3174

LOCATION: JALALABAD AIRFIELD, AFGHANISTAN

DATE OF ACCIDENT: 2 OCTOBER 2015

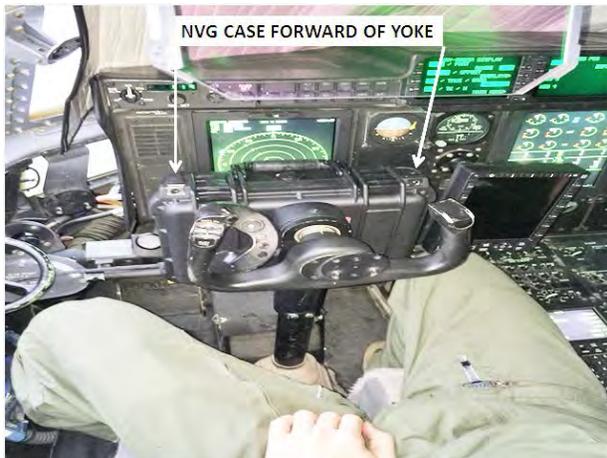
Raising the elevator lifts the control surface above horizontal and is accomplished by pulling the yoke aft (toward the pilot) (Tab CC-54). This request was not considered an unusual request by the MP who complied at 23:19:49L (DFDR time 4710) (Tabs J-11 to J-12, N-4, and CC-54 to CC-55). For the next six minutes, there were changes in the elevator deflection, indicating that the MP was holding the yoke back to maintain between positive 6 and positive 13 degrees of elevator deflection. At 23:26:06L (DFDR time 5087) the elevator position increased to positive 20 degrees deflection momentarily before settling to a position between six to eight degrees positive deflection (Tabs J-11 to J-12 and CC-55). This occurred immediately before the MP told the MCP, “My NVG case is holding...the elevator” as demonstrated in Figures 4-1 and 4-2 (Tabs J-11 to J-12, N-5, Z-3, and Z-19).

Figure 4-1 (Tab Z-3)
Case Forward of Yoke (Daytime)

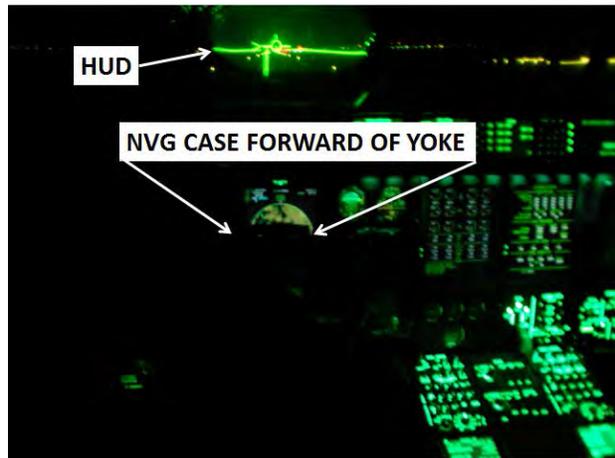
Figure 4-2 (Tab Z-19)
Case Forward of Yoke (Nighttime)

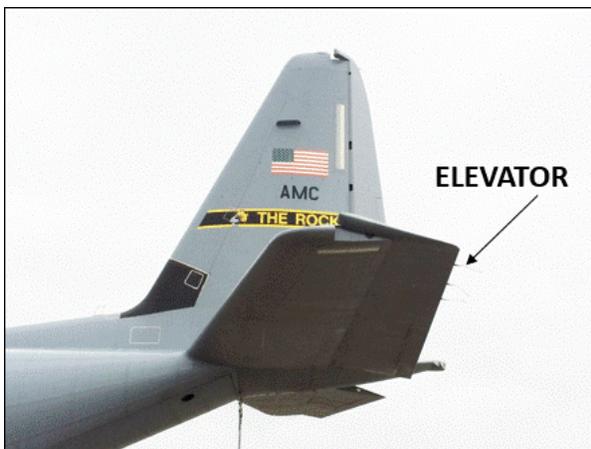
Figure 4-3 (Tab Z-20)
Elevator Without Case Forward of Yoke

The natural resting state of the elevator during ground loading operations is approximately negative 15 degrees deflection, as demonstrated in Figure 4-3 (Tab J-11 to J-12). On the MA, the elevator position remained between six to eight degrees positive deflection while loading

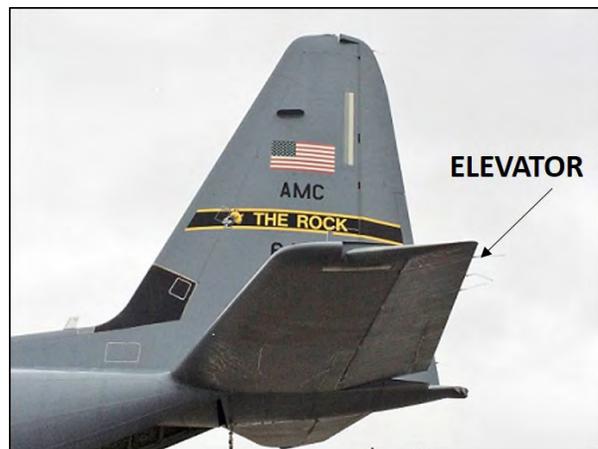
Figure 4-4 (Tab Z-4)
Elevator With Case Forward of Yoke

operations continued, as demonstrated in Figure 4-4 (Tab J-11). This positive elevator deflection was corroborated by video evidence of the MA loading operations, depicted in Figures 4-5 and 4-6 (Tab CC-3). Approximately ten minutes after the hard-shell NVG case was placed forward of the yoke, the MCP got out of the right seat to assist with loading operations in the back of the MA (Tabs N-7 and CC-55).

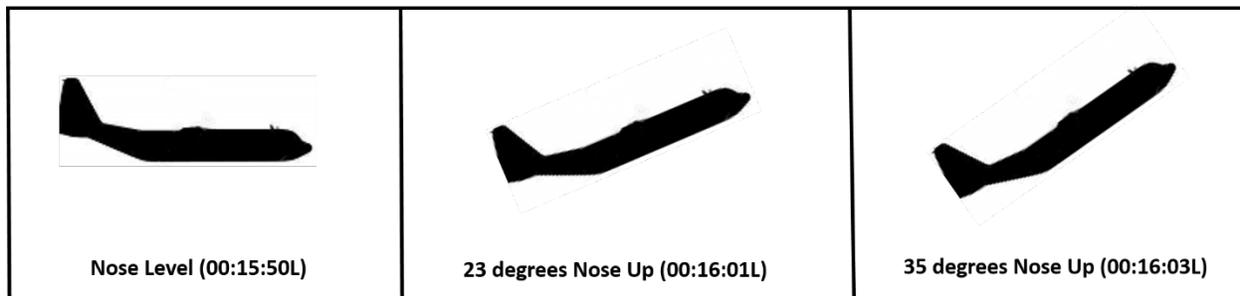
After the MP called "Rotate" at 00:15:50L (Figure 4-11), the MCP responded that the MA was "going off on its own" at 00:15:54L. The MCP became aware of a problem at 00:15:56L when he stated, "Ahh," and verbalized a trim failure two seconds later (00:15:58L) as the MA reached its top airspeed of 117 knots (Tabs J-13 and J-16, L-3, N-17, Z-14, CC-29 to C-32, CC-55, and CC-57). The MCP applied full nose-down trim in an attempt to help move the yoke forward at 00:15:57L (Tabs L-6, CC-55, and CC-57). The trim reached full negative deflection in three seconds, indicating that the trim system was operating normally (Tab L-6). The MA continued to pitch up as the mishap pilots attempted to remedy the perceived trim malfunction (Tabs L-4 and CC-32 to CC-35). Three seconds after the MCP verbalized a trim malfunction, the first stall warning occurred at 00:16:01L (Figure 4-11) (Tabs N-17, Z-14, CC-55, and CC-57). The MA was at greater than 20 degrees nose-up pitch, wings level, and an airspeed of 115 knots (Tabs J-16, L-3 to L-4, and CC-34).

At approximately 00:16:02L, when the MA was at 25 degrees of positive pitch, the MP, already in control of the MA, applied right aileron, and began rolling the MA to the right (Tabs L-4, L-6, J-16, N-17 to N-18, CC-35 to CC-36, and CC-55 to CC-57). This input is consistent with the MP attempting to maintain controlled flight (Tab CC-56). At 00:16:02L, the MA entered a stall and, except for a brief period just prior to impact, remained stalled throughout the remainder of the MS (Tabs J-18, CC-55, and CC-57). At 00:16:03L, the MA issued a second stall warning as the MA's pitch continued to increase through 35 degrees nose-up (Figure 4-11) (Tabs L-4, N-17, Z-14, CC-37, CC-55, and CC-57).

Figure 4-11 (Tab Z-14)
Pitch Angles of MA w/ Time Stamps

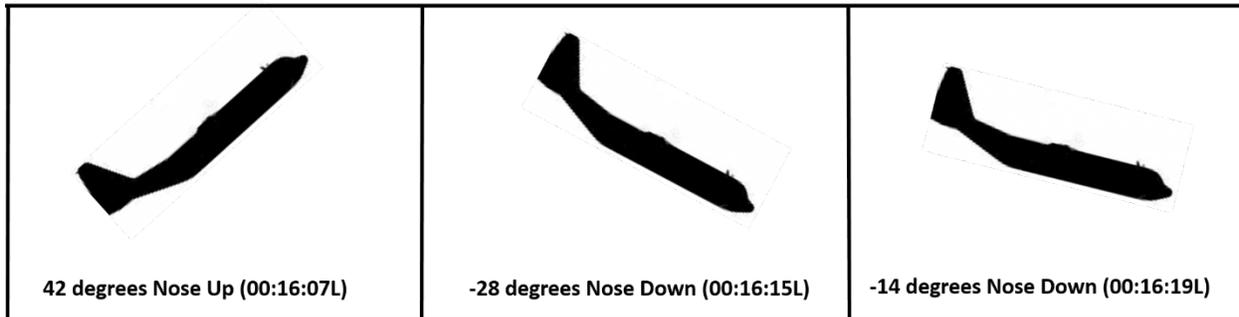
At approximately 00:16:13L, the MA began to roll to the left (Tabs L-4, CC-49, CC-55, and CC-58). The MA's nose continued to drop, eventually reaching negative 28 degrees pitch at 00:16:15L (Figure 4-12) (Tabs J-21, L-4, CC-50, CC-55, and CC-58). At 00:16:15L, the MP stated, "We're going down," a statement he repeated three consecutive times (Tabs N-18, CC-55, and CC-58). At 00:16:15L, the nose-down pitch angle was arrested as the MA nose started to rise (Tabs J-21, L-4, CC-51 to CC-52, CC-55, and CC-58).

Figure 4-12 (Tab Z-14)
Pitch Angles of MA w/ Time Stamps

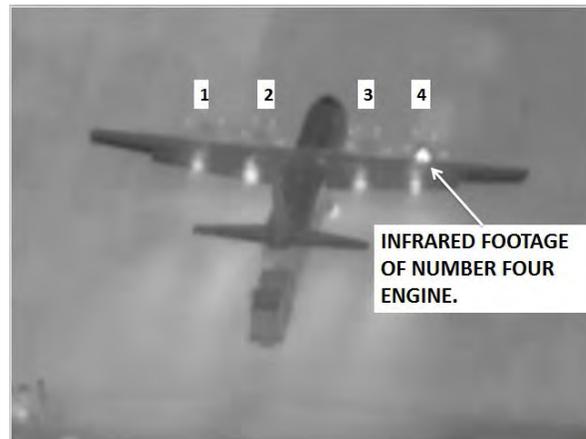
Figure 6-1 (Tab Z-10)

Throughout the ground operations and takeoff sequence, the IR video showed the #4 engine apparently running hot, as indicated by the white color in Figure 6-1 (Tabs CC-14 and Z-10). Upon investigation into the maintenance history of the #4 engine, there was evidence of the #4 engine experiencing high oil temperatures and a sticking oil cooler flap (Tab U-7 and U-9 to U-10). Maintenance replaced the NIU for the sticking oil cooler flap and the oil temperatures were determined to be within limits (Tab U-11). The DFDR confirmed all four engines were operating normally throughout the MS (Tab L-8 to L-10).

IR Image of MA ERO (The numbers denote the specific engine)

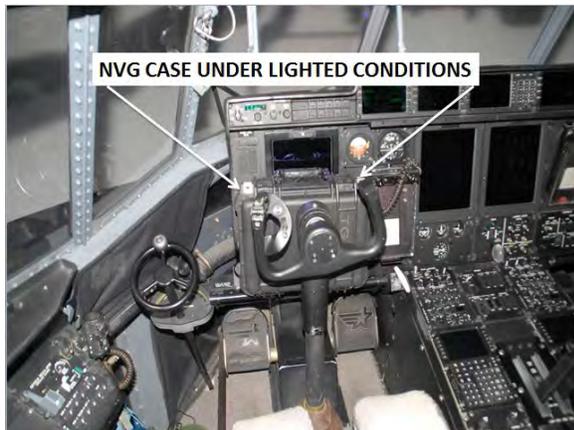
Figure 11-1 (Tab Z-17)
View of HDDs w/ Light

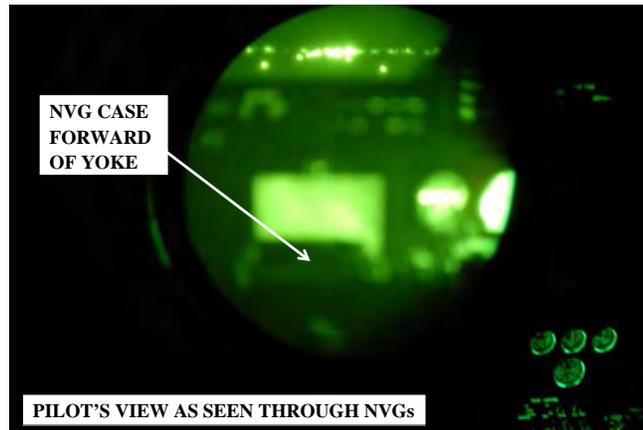
Figure 11-2 (Tab Z-18)
View of HDDs through NVGs

During the AIB's simulations at Little Rock Air Force Base, the AIB Pilot Member (AIB/PM) dimmed flight deck lighting to replicate nighttime operations (Tabs Z-19, CC-9, and CC-56). The hard-shell NVG case placed forward of the yoke became inconspicuous to all three AIB pilots during the course of multiple takeoff sequences (Tab CC-9).
