UNITED STATES AIR FORCE
AIRCRAFT ACCIDENT INVESTIGATION
BOARD REPORT

C-130J, T/N 08-3174

LOCATION: JALALABAD AIRFIELD, AFGHANISTAN

DATE OF ACCIDENT: 2 OCTOBER 2015

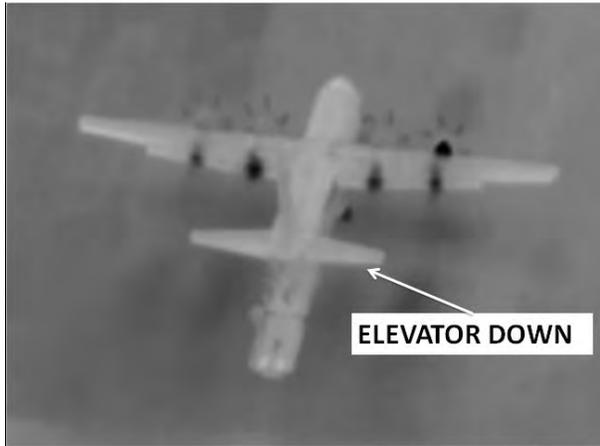
Figure 4-5 (Tab Z-5)
Elevator Down Position

operations continued, as demonstrated in Figure 4-4 (Tab J-11). This positive elevator deflection was corroborated by video evidence of the MA loading operations, depicted in Figures 4-5 and 4-6 (Tab CC-3). Approximately ten minutes after the hard-shell NVG case was placed forward of the yoke, the MCP got out of the right seat to assist with loading operations in the back of the MA (Tabs N-7 and CC-55).

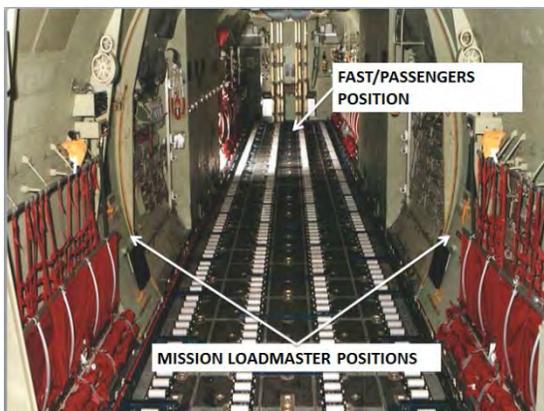
Figure 4-7 (Tab Z-7)
C-130J Cargo Area

The MLs were tasked with unloading five pallets utilizing ERO procedures (Tab K-32). The onload also included five passengers not included in the original load plan, prompting a decision by the MLs to move the forward-most pallet aft to pallet position three rather than pallet position two (Tabs K-25, K-32, and R-14 to R-15). This decision was in accordance with (IAW) AFI 11-2C-130J Volume 3, *C-130J Operations Procedures*, 8 December 2009 (Tab BB-17). This load change shifted the center of gravity (CG) to 28.6% of Mean Aerodynamic Chord (MAC) for takeoff (Tab N-8). The total load weight was 40,300 pounds (including the passengers) and the calculated aircraft gross weight for takeoff was 153,200 pounds (Tabs J-12, N-8, and CC-23). The cargo weight and CG computed based on the new load plan was within flight limits and met all requirements for safe flight (Tab CC-23).

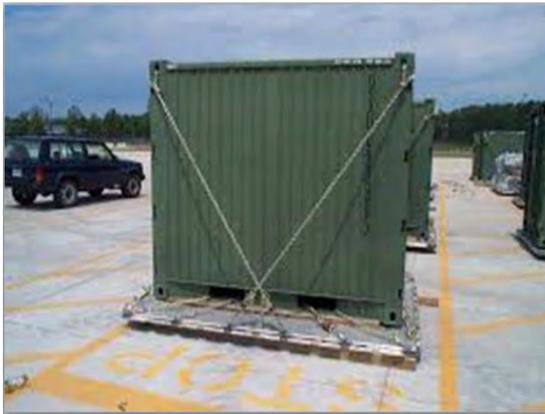
Figure 4-9 (Tab Z-8)
463L Pallet w/ Tri-Con

The cargo consisted of five Tri-Con shipping containers placed on 463L pallets and restrained with MB-1 tie-down chains and devices as demonstrated in Figures 4-9 and 4-10 (Tabs K-32, N-8, R-18 to R-19, and V-4.3). All cargo was restrained and tied-down with devices and chains sufficient for flight IAW Technical Order (TO) 1C-130J-9, *Cargo Loading Manual; C-130J Aircraft*, 1 January 2015 (Tab BB-68 to BB-76). A United States Air Force (USAF) Joint Inspector (JI) visually inspected all cargo during pallet build operations. Additionally, the JI ensured the Tri-Cons were braced and packed to prevent an inflight CG shift. All pallets were weighed and marked for flight (Tab V-4.3 to V-4.5).

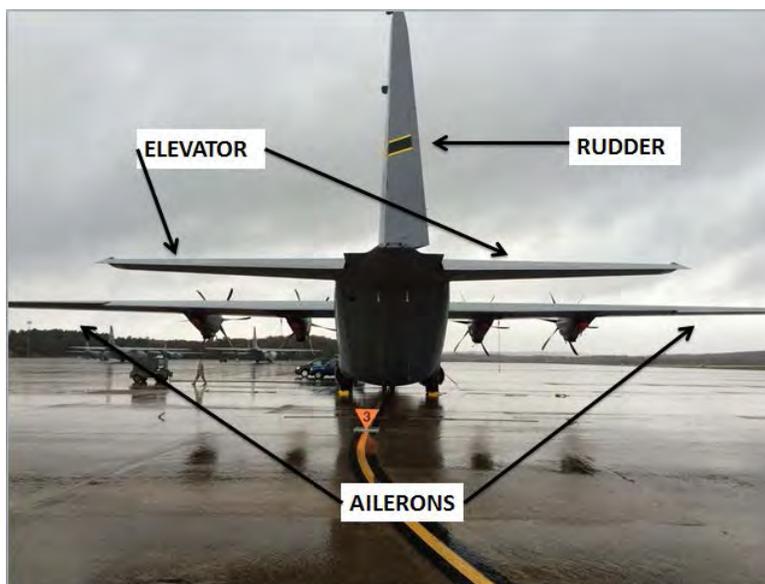
Figure 6-2 (Tab Z-11)
Primary Flight Controls

The flight control systems of the MA included the primary flight controls, trim systems, the flaps, and portions of the stall warning system (Tab BB-35). The primary flight controls included the ailerons, rudder, and elevators (Tab BB-35). The secondary flight controls included the aileron trim, rudder trim, elevator trim, and flap control systems (Tab BB-35). Flight controls maintained the attitude and directional control of the MA (Tab BB-35). Each pilot had a complete set of controls (Tab BB-35). Flight control inputs were transmitted to the booster assemblies through mechanical rods and cables (Tab BB-35). Elevators were controlled by fore and aft movement of the control yoke columns (Tab BB-35). The rudder was controlled by pushing the rudder pedals (Tab BB-35).
